Re: Compliance Evaluation Inspections  
Concrete Supply Company, Lincolnton, NC  
NPDES Permit No. NCG140046

## Water Compliance Inspection Report

Concrete Supply Company - Lincolnton Plant

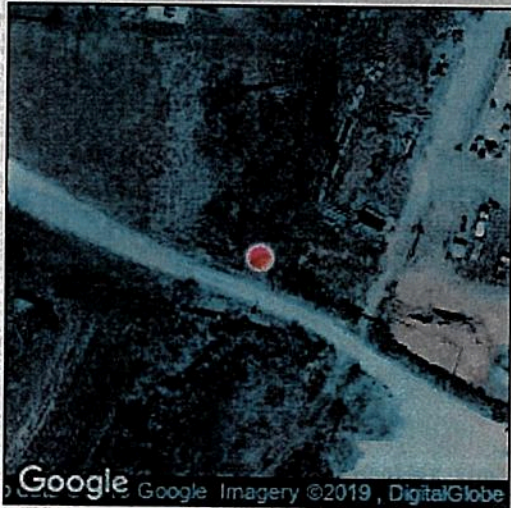
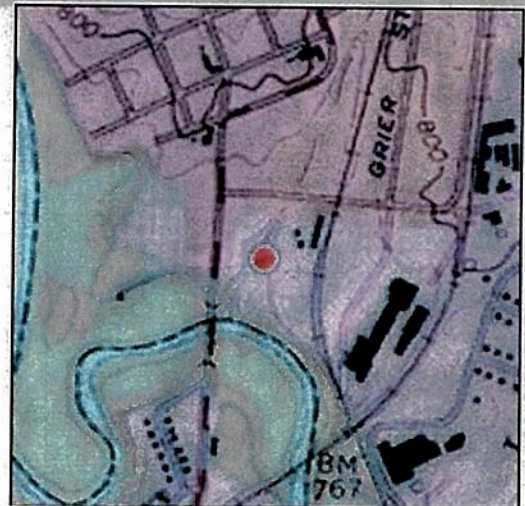
File Name	DSCN1837.JPG
Description	Photograph of the bermed area and inlet at Outfall 1. This outfall, located in the northwest corner of the site, has the potential to discharge both stormwater and wastewater.
Latitude	N 35° 27' 40.60"
Longitude	W 81° 15' 38.43"

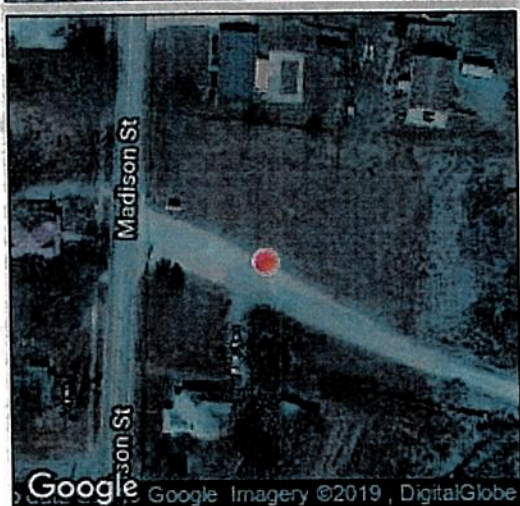
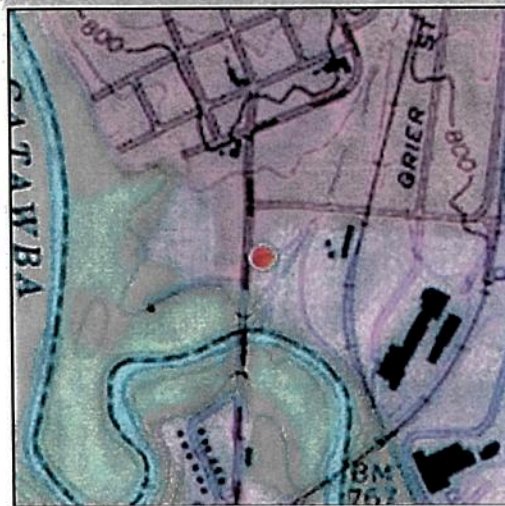
File Name	DSCN1838.JPG
Description	Photograph of the outlet for Outfall 1. This outfall, located in the northwest corner of the site, has the potential to discharge both stormwater and wastewater. The area downgradient of the outfall had what appeared to be accumulated silty material from the concrete process.
Latitude	N 35° 27' 41.38"
Longitude	W 81° 15' 40.91"

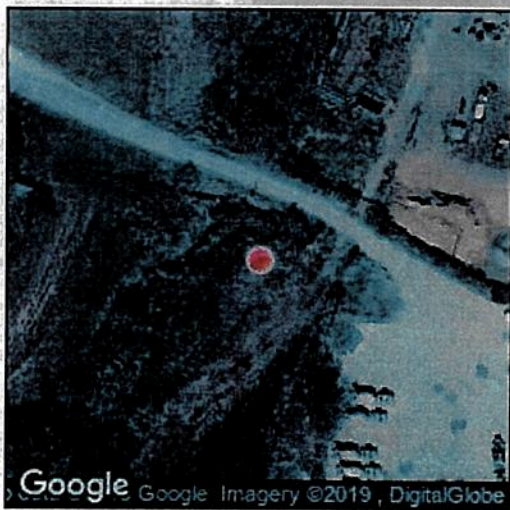
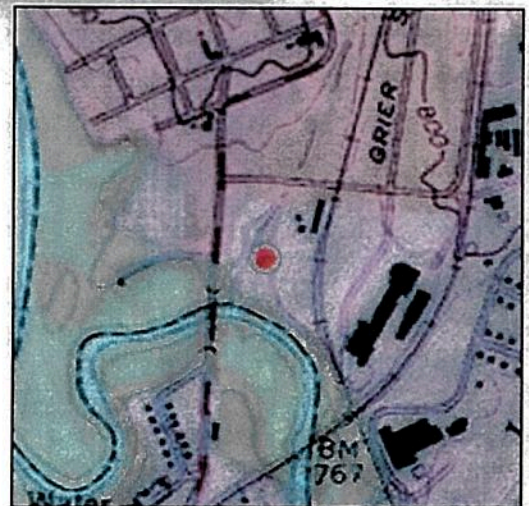
File Name	DSCN1839.JPG
Description	Photograph of the ditch down gradient of Outfall 1 leading towards the creek. This area appeared to be accumulated silty material from the concrete process. Pooling water was observed in locations in the ditch in addition to the evidence of erosion features.
Latitude	N 35° 27' 39.65"
Longitude	W 81° 15' 38.42"

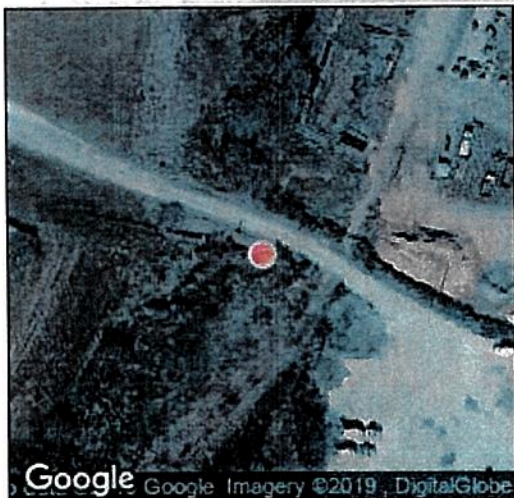
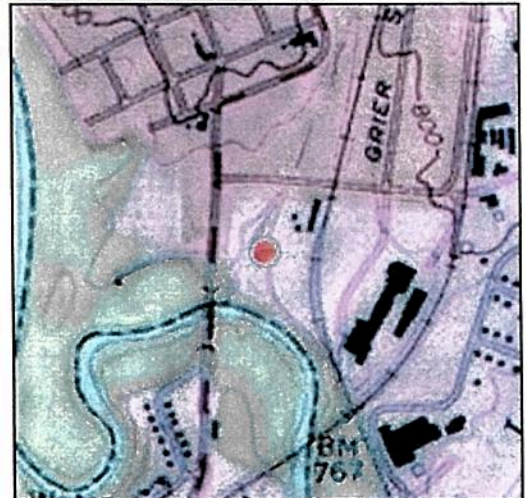
File Name	DSCN1840.JPG
Description	Photograph of the ditch down gradient of Outfall 1 leading towards the creek. Pooling water was observed in locations in the ditch in addition to the evidence of erosion features.
Latitude	N 35° 27' 40.00"
Longitude	W 81° 15' 38.26"

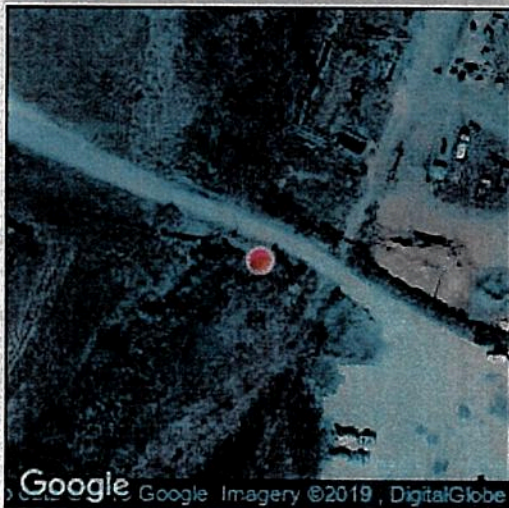
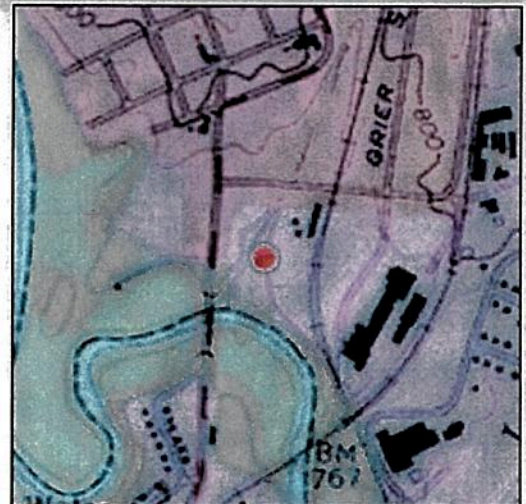
File Name	DSCN1841.JPG
Description	Photograph of the ditch down gradient of Outfall 1 leading towards the creek. Pooling water was observed in locations in the ditch in addition to the evidence of erosion features.
Latitude	N 35° 27' 39.98"
Longitude	W 81° 15' 38.25"

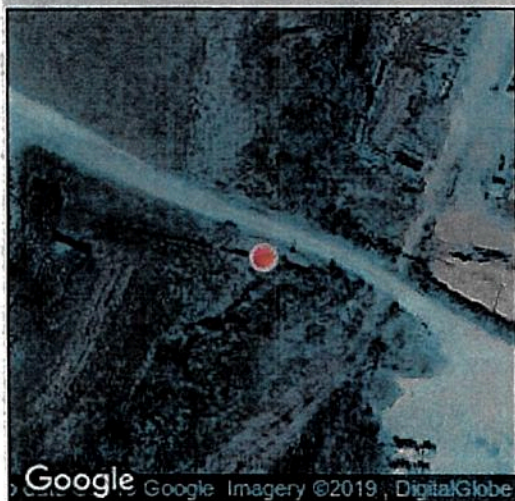
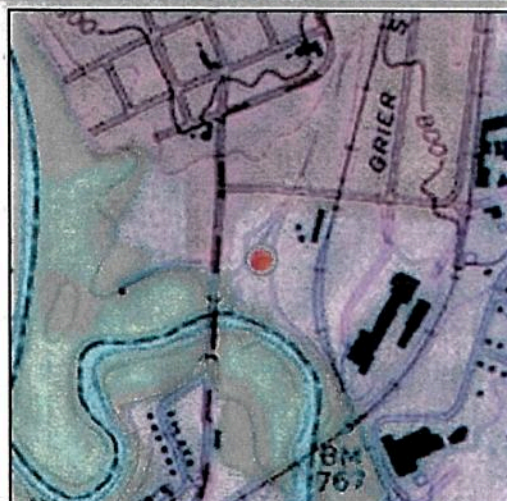
File Name	DSCN1842.JPG
Description	Photograph of the junction between the creek and the ditch down gradient of Outfall 1.
Latitude	N 35° 27' 40.12"
Longitude	W 81° 15' 38.76"

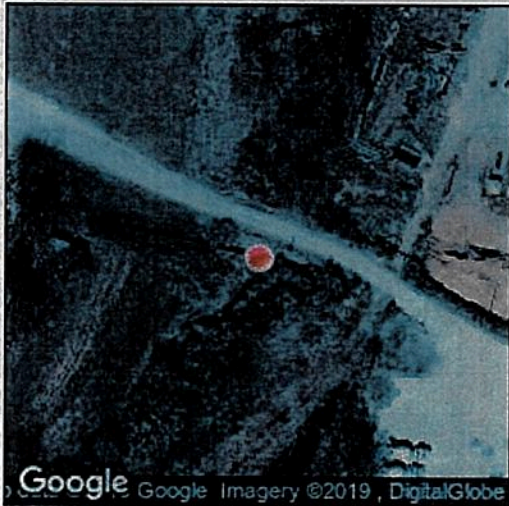
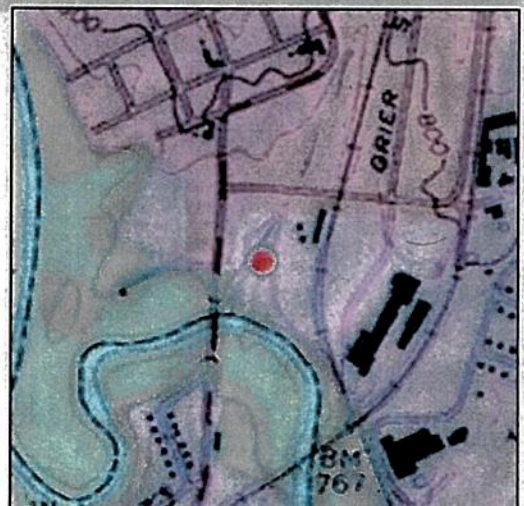
File Name	DSCN1843.JPG
Description	Photograph of the ditch up gradient of junction with the creek.
Latitude	N 35° 27' 40.11"
Longitude	W 81° 15' 38.78"

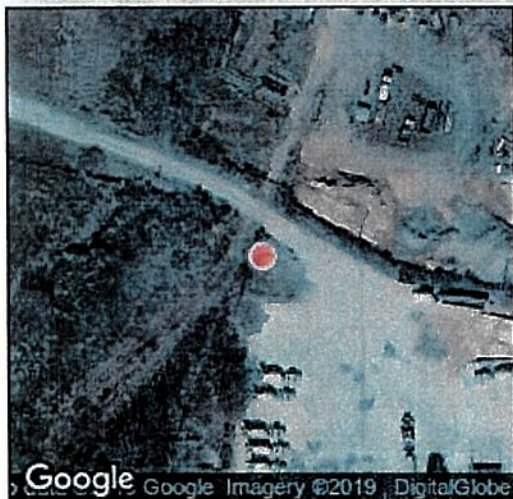
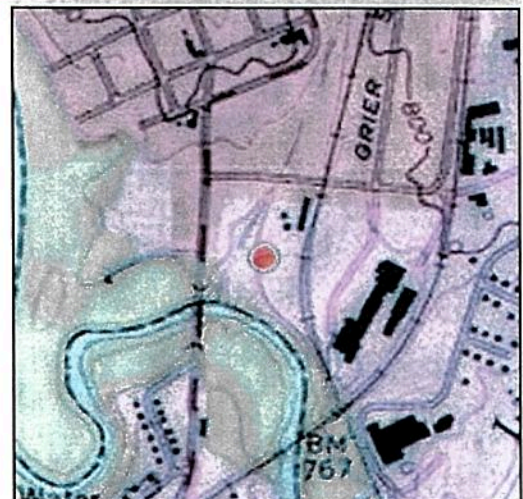
File Name	DSCN1844.JPG
Description	Photograph of the berm and inlet to the pipe for Outfall 1. During the inspection, the facility side of the berm had damp accumulated sediment to the level of the outfall pipe.
Latitude	N 35° 27' 39.54"
Longitude	W 81° 15' 37.48"

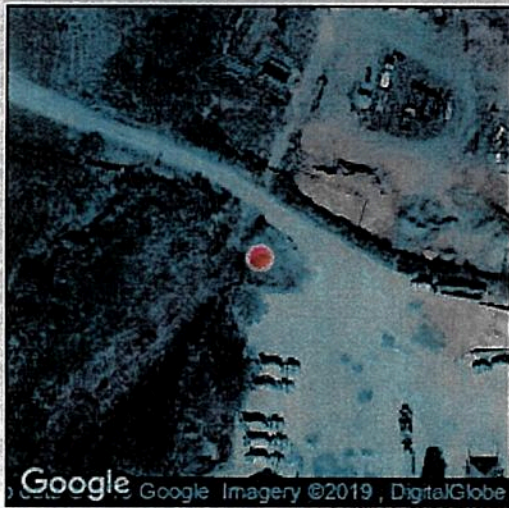
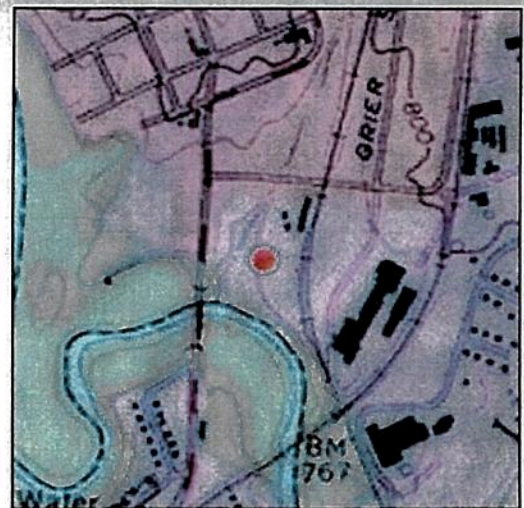
File Name	DSCN1845.JPG
Description	Photograph of the berm along the river near the outfall.
Latitude	N 35° 27' 39.45"
Longitude	W 81° 15' 37.51"

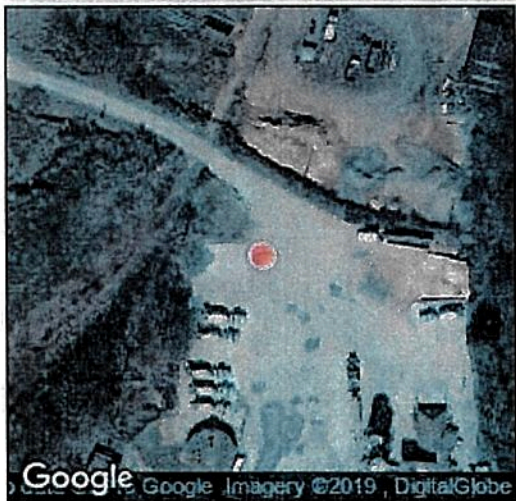
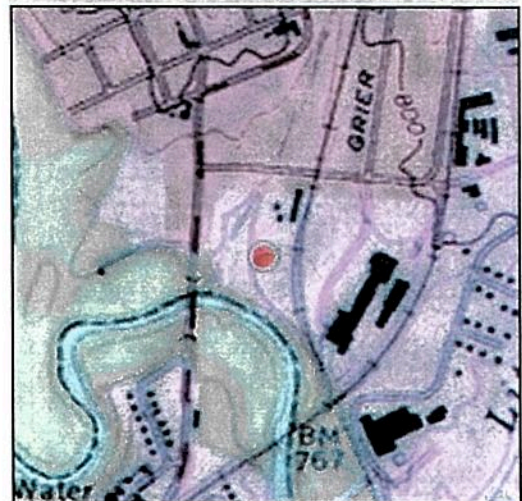
File Name	DSCN1846.JPG
Description	Photograph of wastewater from truck washing operations observed during the site running towards the bermed area near the outfall.
Latitude	N 35° 27' 39.07"
Longitude	W 81° 15' 36.97"

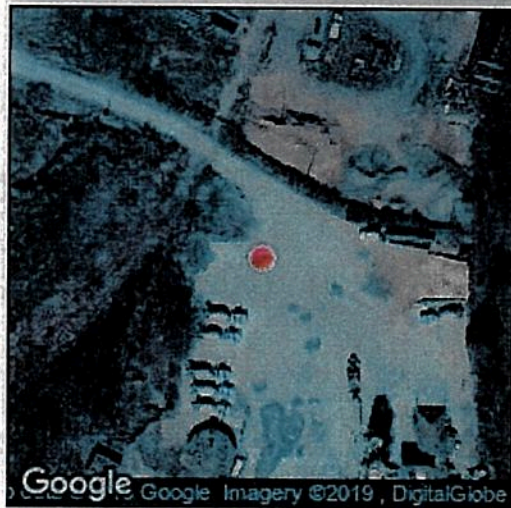
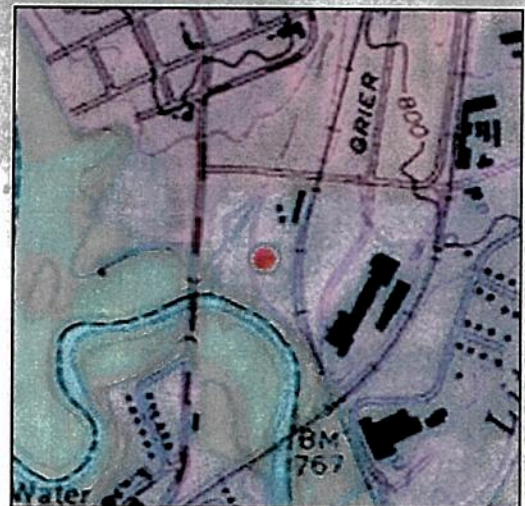
File Name	DSCN1847.JPG
Description	Photograph of wastewater from truck washing operations observed during the site running towards the bermed area near the outfall.
Latitude	N 35° 27' 39.04"
Longitude	W 81° 15' 36.99"

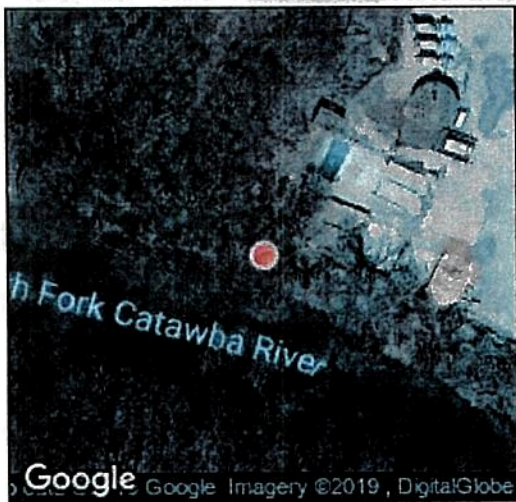
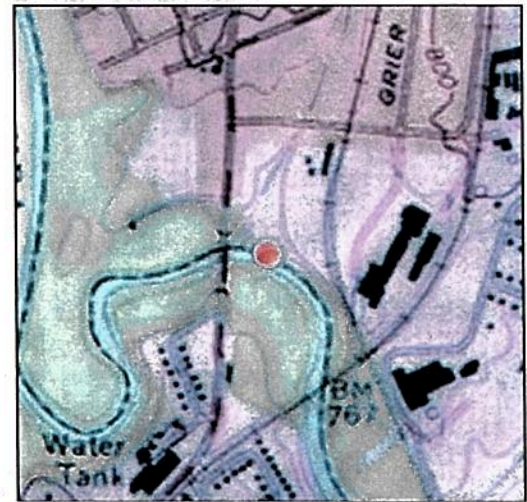
File Name	DSCN1848.JPG
Description	Photograph of the truck wash station near the concrete wash pit.
Latitude	N 35° 27' 36.32"
Longitude	W 81° 15' 39.12"

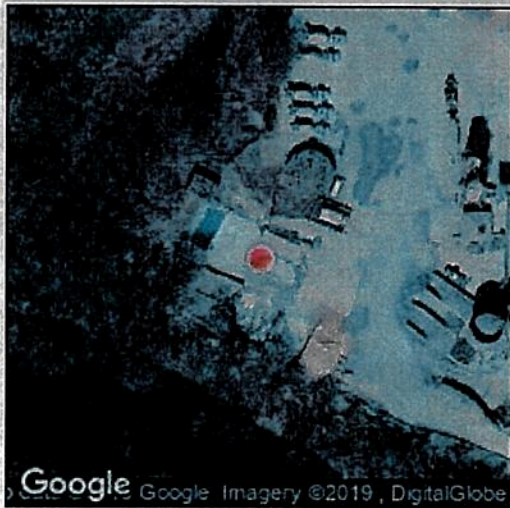
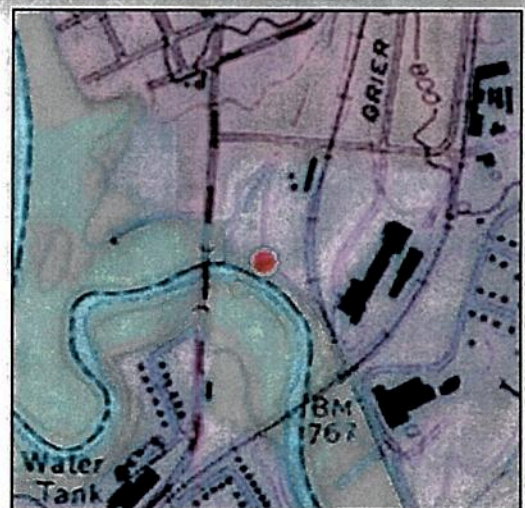
File Name	DSCN1849.JPG
Description	Photograph of the concrete washout basin.
Latitude	N 35° 27' 36.85"
Longitude	W 81° 15' 37.93"

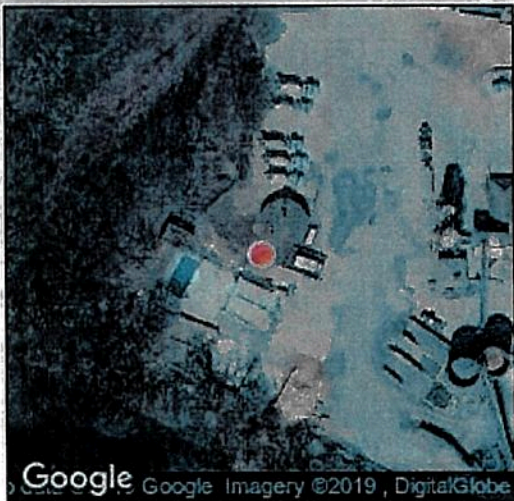
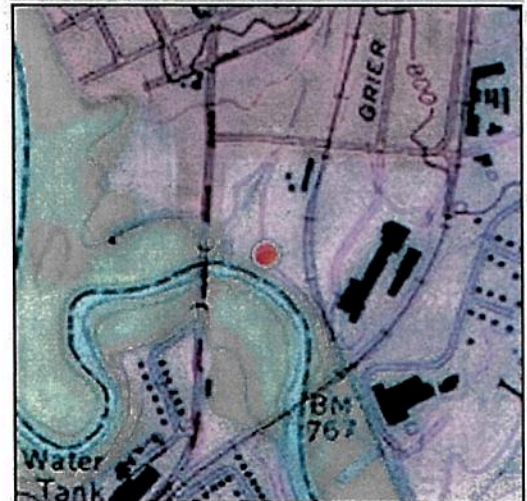
Pollutant Sources	Note location, quantitative description, design issue, O&M deficiencies (including the nature and extent), and pollutants off-site
<p><b>Mixing Drum Cleanouts</b></p>	<p>Concrete trucks have their drums washed at the wash station in the southwest corner of the site (see photo DSCN1848). Once rinsed, the wastewater from the drums are emptied into a concrete washout basin to allow for the removing of particulates. These series of concrete washout basins can be seen in photos DSCN1849-DSCN1851. If required, a pH treatment can be performed in the basin to adjust the pH prior to discharging. According to facility personnel, there is never a discharge from the clear water pit at the end or the treatment series due to the facility's ability to pump the wastewater from the pit to the City of Lincolnton storm sewer drain (seen in photo DSCN1850).</p>

- A concrete sheen/accumulation was observed in the City of Lincolnton's sewer man hole likely from the discharging of concrete wash water to the sewer drain.

File Name	DSCN1850.JPG
Description	Photograph of the municipality's sanitary sewer manhole near the concrete washout station. According to facility personnel, it periodically pump concrete washout water via a portable pump into this sanitary sewer manhole.
Latitude	N 35° 27' 37.25"
Longitude	W 81° 15' 37.67"

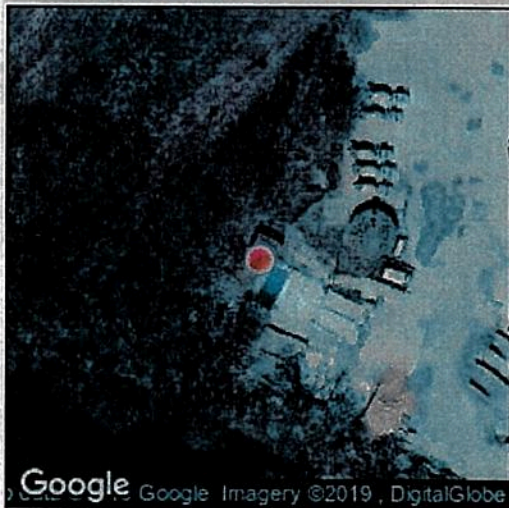
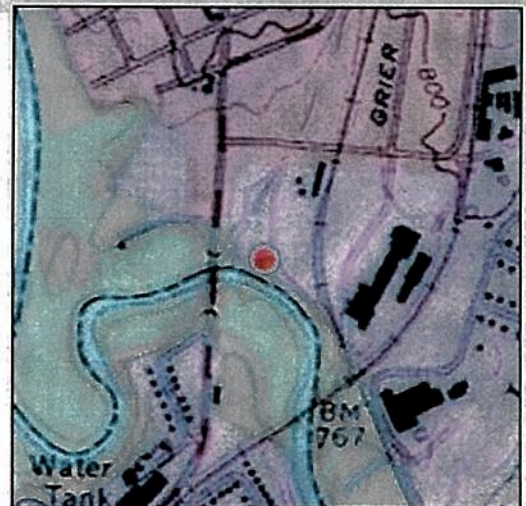
File Name	DSCN1851.JPG
Description	Photograph of the final treatment cell (Bright well) of the concrete washout. The water from this cell can be used in the process, dust suppression, or directed to the city sanitary sewer manhole.
Latitude	N 35° 27' 37.30"
Longitude	W 81° 15' 38.54"

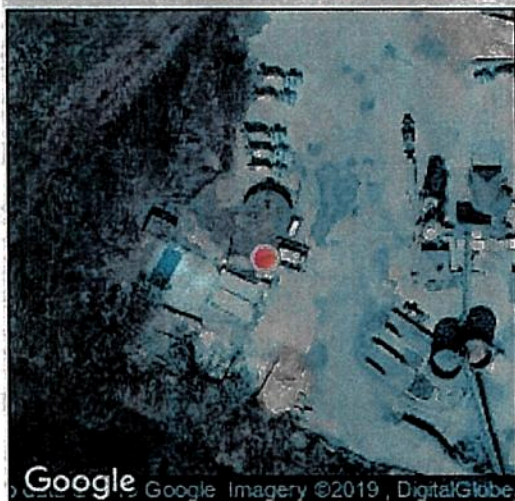
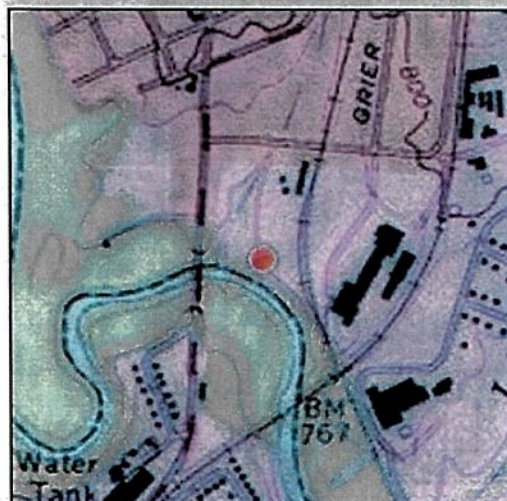
File Name	DSCN1852.JPG
Description	Photograph of the diesel fuel tank and its secondary containment structure. A drainage valve was observed in the secondary containment structure. The valve was closed at the time of the inspection. Although a lock was not in place on the valve, the valve arm had been removed.
Latitude	N 35° 27' 37.16"
Longitude	W 81° 15' 37.49"

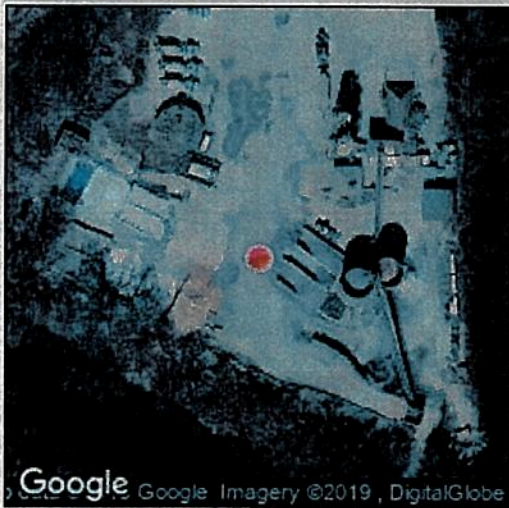
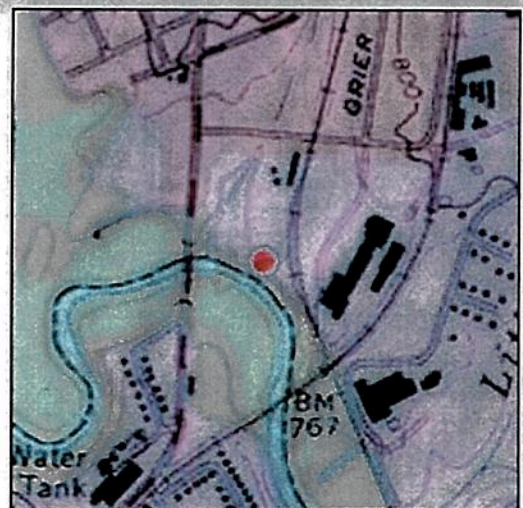
File Name	DSCN1853.JPG
Description	Photograph of the outdoor material storage piles.
Latitude	N 35° 27' 36.50"
Longitude	W 81° 15' 36.70"

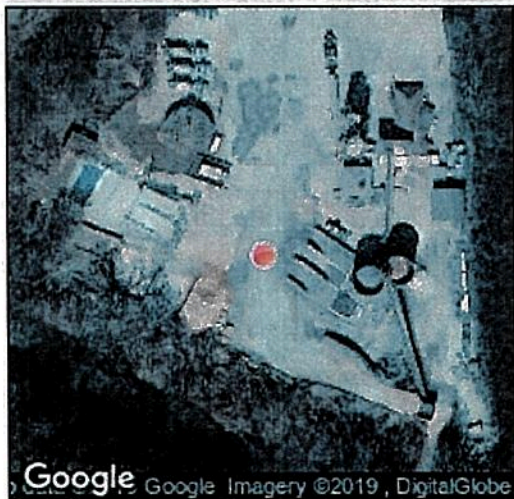
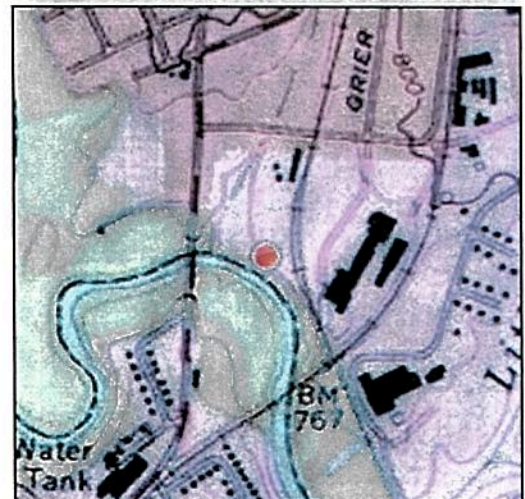
File Name	DSCN1854.JPG
Description	Photograph of the material storage piles. Some sediment tracking was observed from the sand storage pile. A concrete waste storage area can be seen in the back of the photograph along the south side of the property.
Latitude	N 35° 27' 36.51"
Longitude	W 81° 15' 36.76"

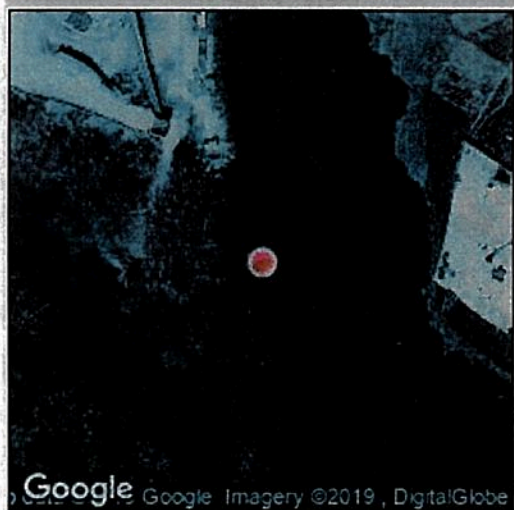
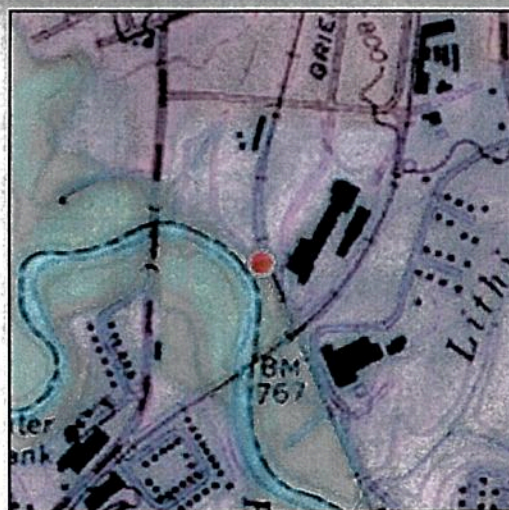
File Name	DSCN1855.JPG
Description	Junction point with the stream and the old outfall from the site which was considered closed out and removed from its permit requirements.
Latitude	N 35° 27' 34.22"
Longitude	W 81° 15' 34.22"
